RADIATION DAMAGE TO MAGNET WATER HOSES AT THE APS*

Abstract

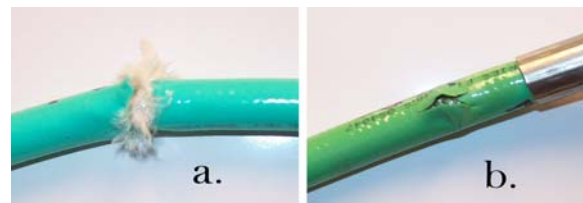
Two different burst types are shown in figure 1. Hose bursts occur when three layers: the core, the fiber reinforcement, and the outer jacket, all fail simultaneously. The cover bubble burst can occur when the core fails and the fluid medium passes through the fiber reinforcement bursting through the outer jacket. The cover bubble burst can also occur when the fluid medium works its way between the core material and the inner tube of the fitting and returns between the core and the outer jacket (through the fiber reinforcement) and ruptures through the outer jacket. The fiber reinforcement remains intact in a cover bubble burst. All hose bursts for hoses 6, 7, 8, and 10 occurred between 150 to 200 mm from the fitting that was closest to the radiation source. All hose bursts for hoses 11 through 16 occurred at least 175 mm away from either fitting. All cover bubble bursts occurred between 20 to 38 mm from the fitting that was nearest to the radiation source. All cover bubble bursts were caused by the core cracking and the fluid medium passing through the fiber reinforcement and bursting through the outer jacket.

Figure 1: Types of bursts: (a) *hose burst* (b) *cover bubble burst*.

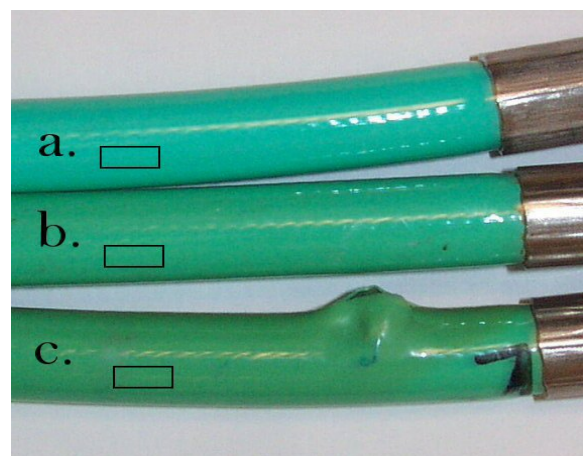
Figures 2, 3 and 4 show the color change that occurs after hoses are exposed to x-ray radiation. The red, green, blue (RGB) values in all figures are obtained by taking the average value, inside the corresponding rectangle, using a photo editor. Rectangles were chosen to minimize any glare or light reflection that would distort the RGB color value. Figure 2 shows the color change of the outer jacket. Figure 3 shows the color change in the fiber reinforcement. Figure 4 shows the color change of the core material.

Figure 2: Color change in the outer jacket.
(a) Hose No. 15 (RGB=4, 173, 152).
(b) Hose No. 8 (RGB= 34, 157, 115).
(c) Hose No. 4 (RGB= 50, 139, 92).

Color change is a method that could be an indicator of how much radiation exposure the hose has had. For this particular type of hose, the color change appears to be most noticeable in the core material (polybutylene terephthalate based), the fiber reinforcement has the least noticeable color change, while the outer jacket falls somewhere in between. It would be most desirable to monitor the color change in the core, but the core cannot be seen while the hose is installed and operating. It might be worth while to investigate whether hose manufacturers can make a hose with an outer jacket that is highly susceptible to color change when exposed to radiation. Thus the entire hose would be like a dosimeter. Sections of a hose exposed to higher doses of radiation would become darker. This could be compared to a color chart to determine if the hose requires replacement.

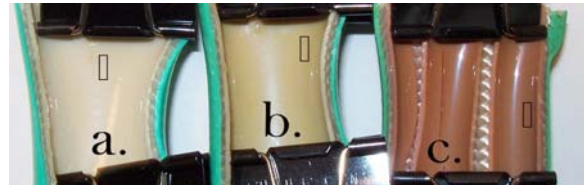
The core material became very brittle and cracked easily when exposed to higher doses of radiation. Figure 4c shows the core material cracked in several places. This cracking occurred while unfolding the hose to take this photograph. Also the adhesive used to bond the hose layers together degraded from radiation exposure. The upper right of figure 4c shows where the outer jacket delaminated from the fiber reinforcement. This delaminating occurred while unfolding the hose to take this photograph. All layers from the sample in figure 4c can easily be pulled apart by hand but the layers from the samples in figure 4a and 4b are strong and cannot be easily pulled apart by hand.

Figure 4: Color change in the core.

(a) Hose No. 15 (RGB= 217, 206, 184).

(b) Hose No. 8 (RGB= 192, 171, 119).

(c) Hose No. 4 (RGB= 139, 88, 65).
